[Docket No. FAA-2004-18744; Directorate Identifier 2004-CE-24-AD; Amendment 39-13910; AD 2004-25-22]

Airworthiness Directives; Great Lakes Aircraft Company, LLC, Models 2T-1A-1 and 2T-1A-2 Airplanes

ACTION: Final rule.

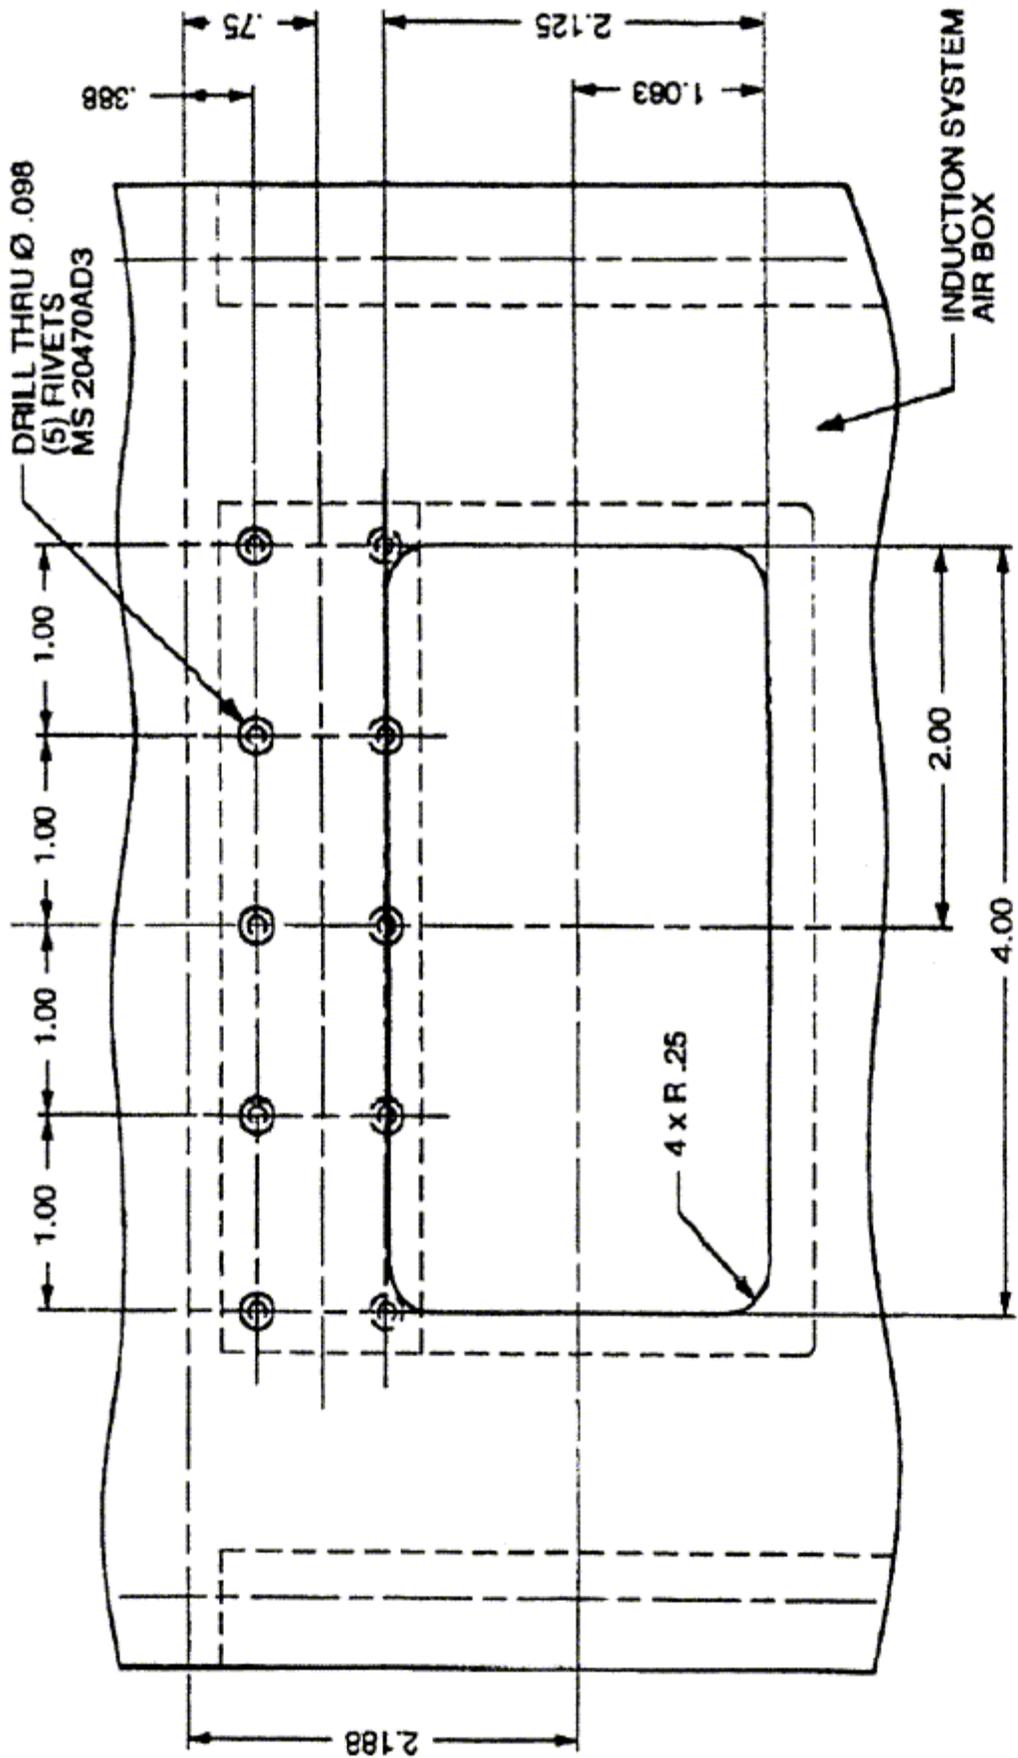
Figure 1

GREAT LAKES AIRCRAFT, TYPES 2T-1A-1 AND 2T-1A-2
 ENGINE INDUCTION SYSTEM AD 79-20-08
 ALTERNATE AIR DOOR INSTALLATION
 FULL SCALE

(2) Visually inspect the alternate air door for distortion, heat damage, and cracks. If any damage is found, repair or fabricate a new door following Figure 1, Figure 2, and Figure 3 in this AD.	<i>For airplanes previously affected by AD 79–20–08:</i> Initially inspect at the next scheduled inspection required by AD 79–20–08 or within the next 25 hours TIS after January 28, 2005 (the effective date of this AD), whichever occurs later. Repetitively inspect thereafter at intervals not to exceed 100 hours TIS. <i>For airplanes not previously affected by AD 79–20–08:</i> Inspect within the next 25 hours TIS after January 28, 2005 (the effective date of this AD). Repetitively inspect thereafter at intervals not to exceed 100 hours TIS. <i>For all affected airplanes:</i> After each inspection, if damage is found during any inspection, before further flight, repair, replace the damaged alternate air door.	Not applicable.

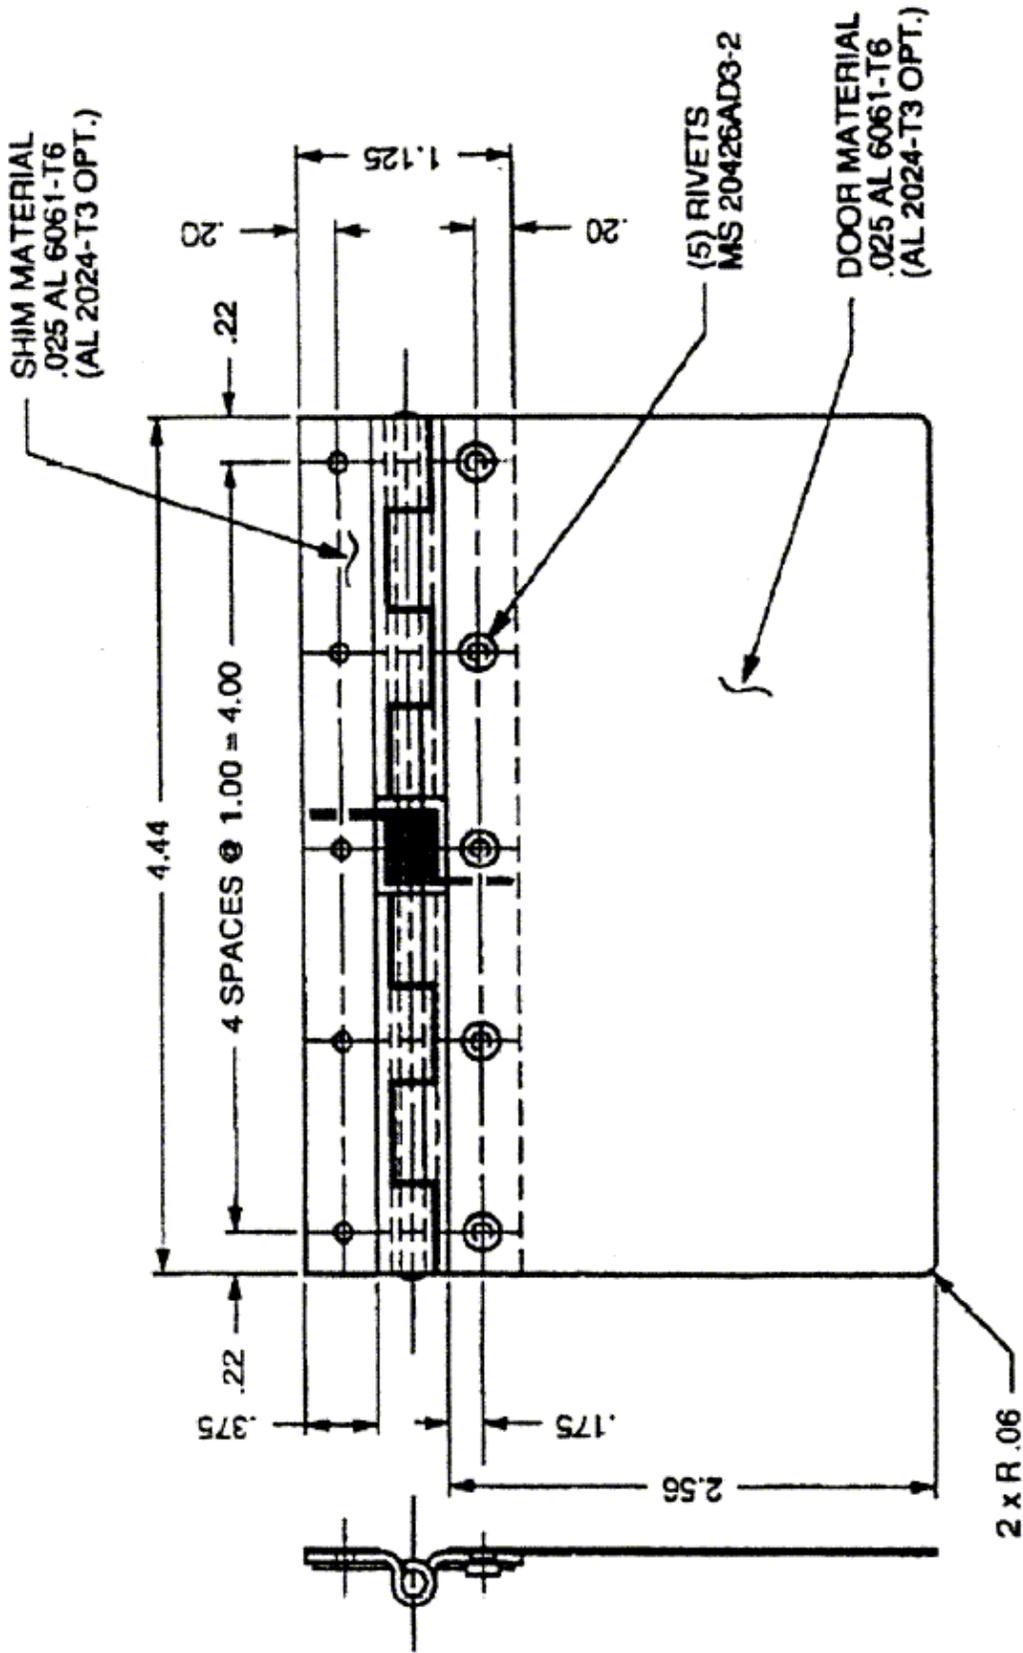
Figure 2

GREAT LAKES AIRCRAFT, TYPES 2T-1A-1 AND 2T-1A-2
ENGINE INDUCTION SYSTEM AD 79-20-08
ALTERNATE AIR DOOR FABRICATION DETAIL
FULL SCALE

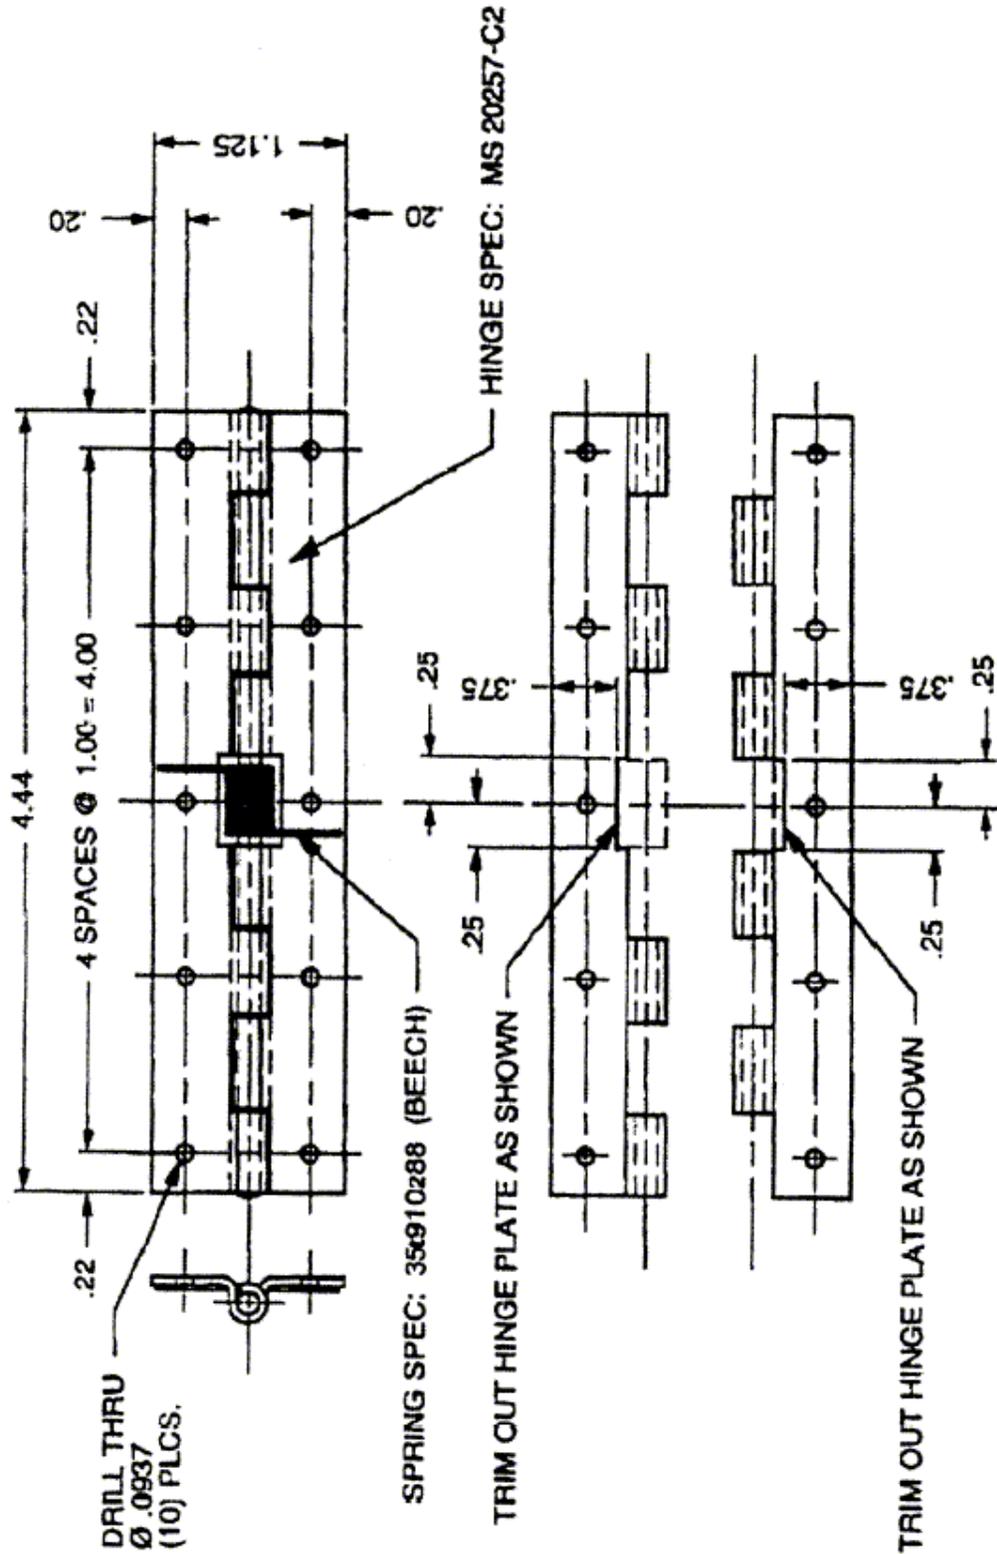
Figure 3

GREAT LAKES AIRCRAFT, TYPES 2T-1A-1 AND 2T-1A-2
 ENGINE INDUCTION SYSTEM AD 79-20-08
 ALTERNATE AIR DOOR HINGE DETAIL
 FULL SCALE
